# HISTORIC PRESERVATION COMMISSION STAFF REPORT

**SUBJECT:** DSA-14-00155: Certificate of Appropriateness

1. **DSA-14-00155:** Certificate of Appropriateness for the Demolition of the apartment building located east of the Fisher Memorial Home within the Katherine J. Drew 2<sup>nd</sup> Addition to Casa Grande located at 300 E. 8<sup>th</sup> Street.

## Exhibit C – Property Inspection Report

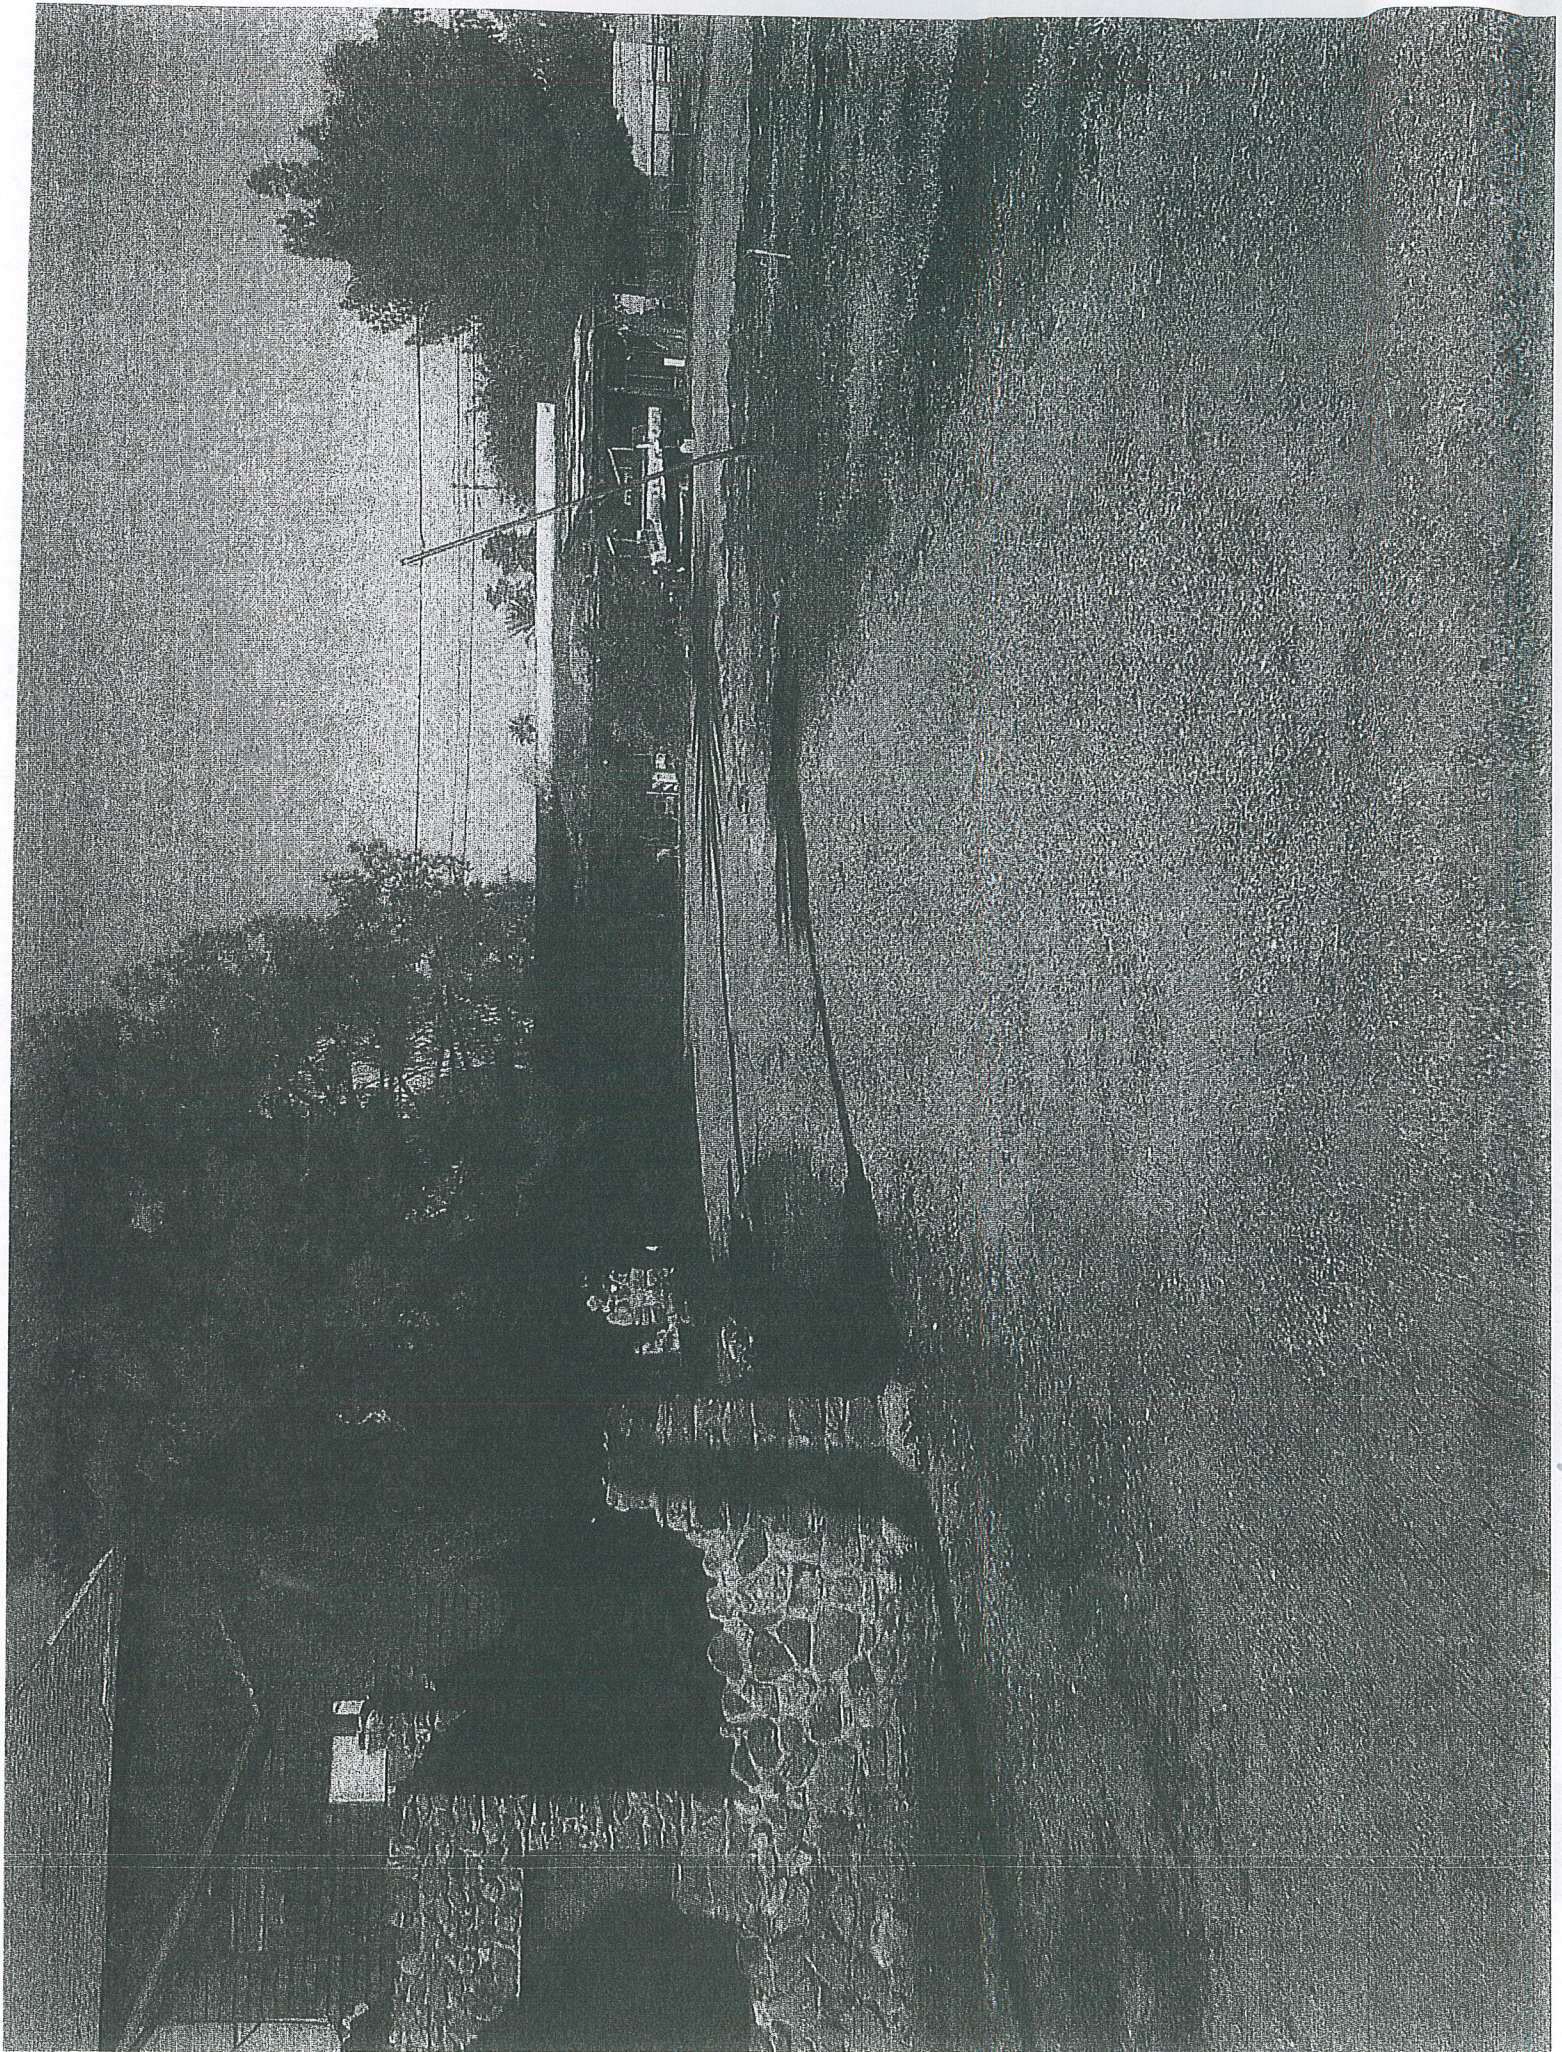
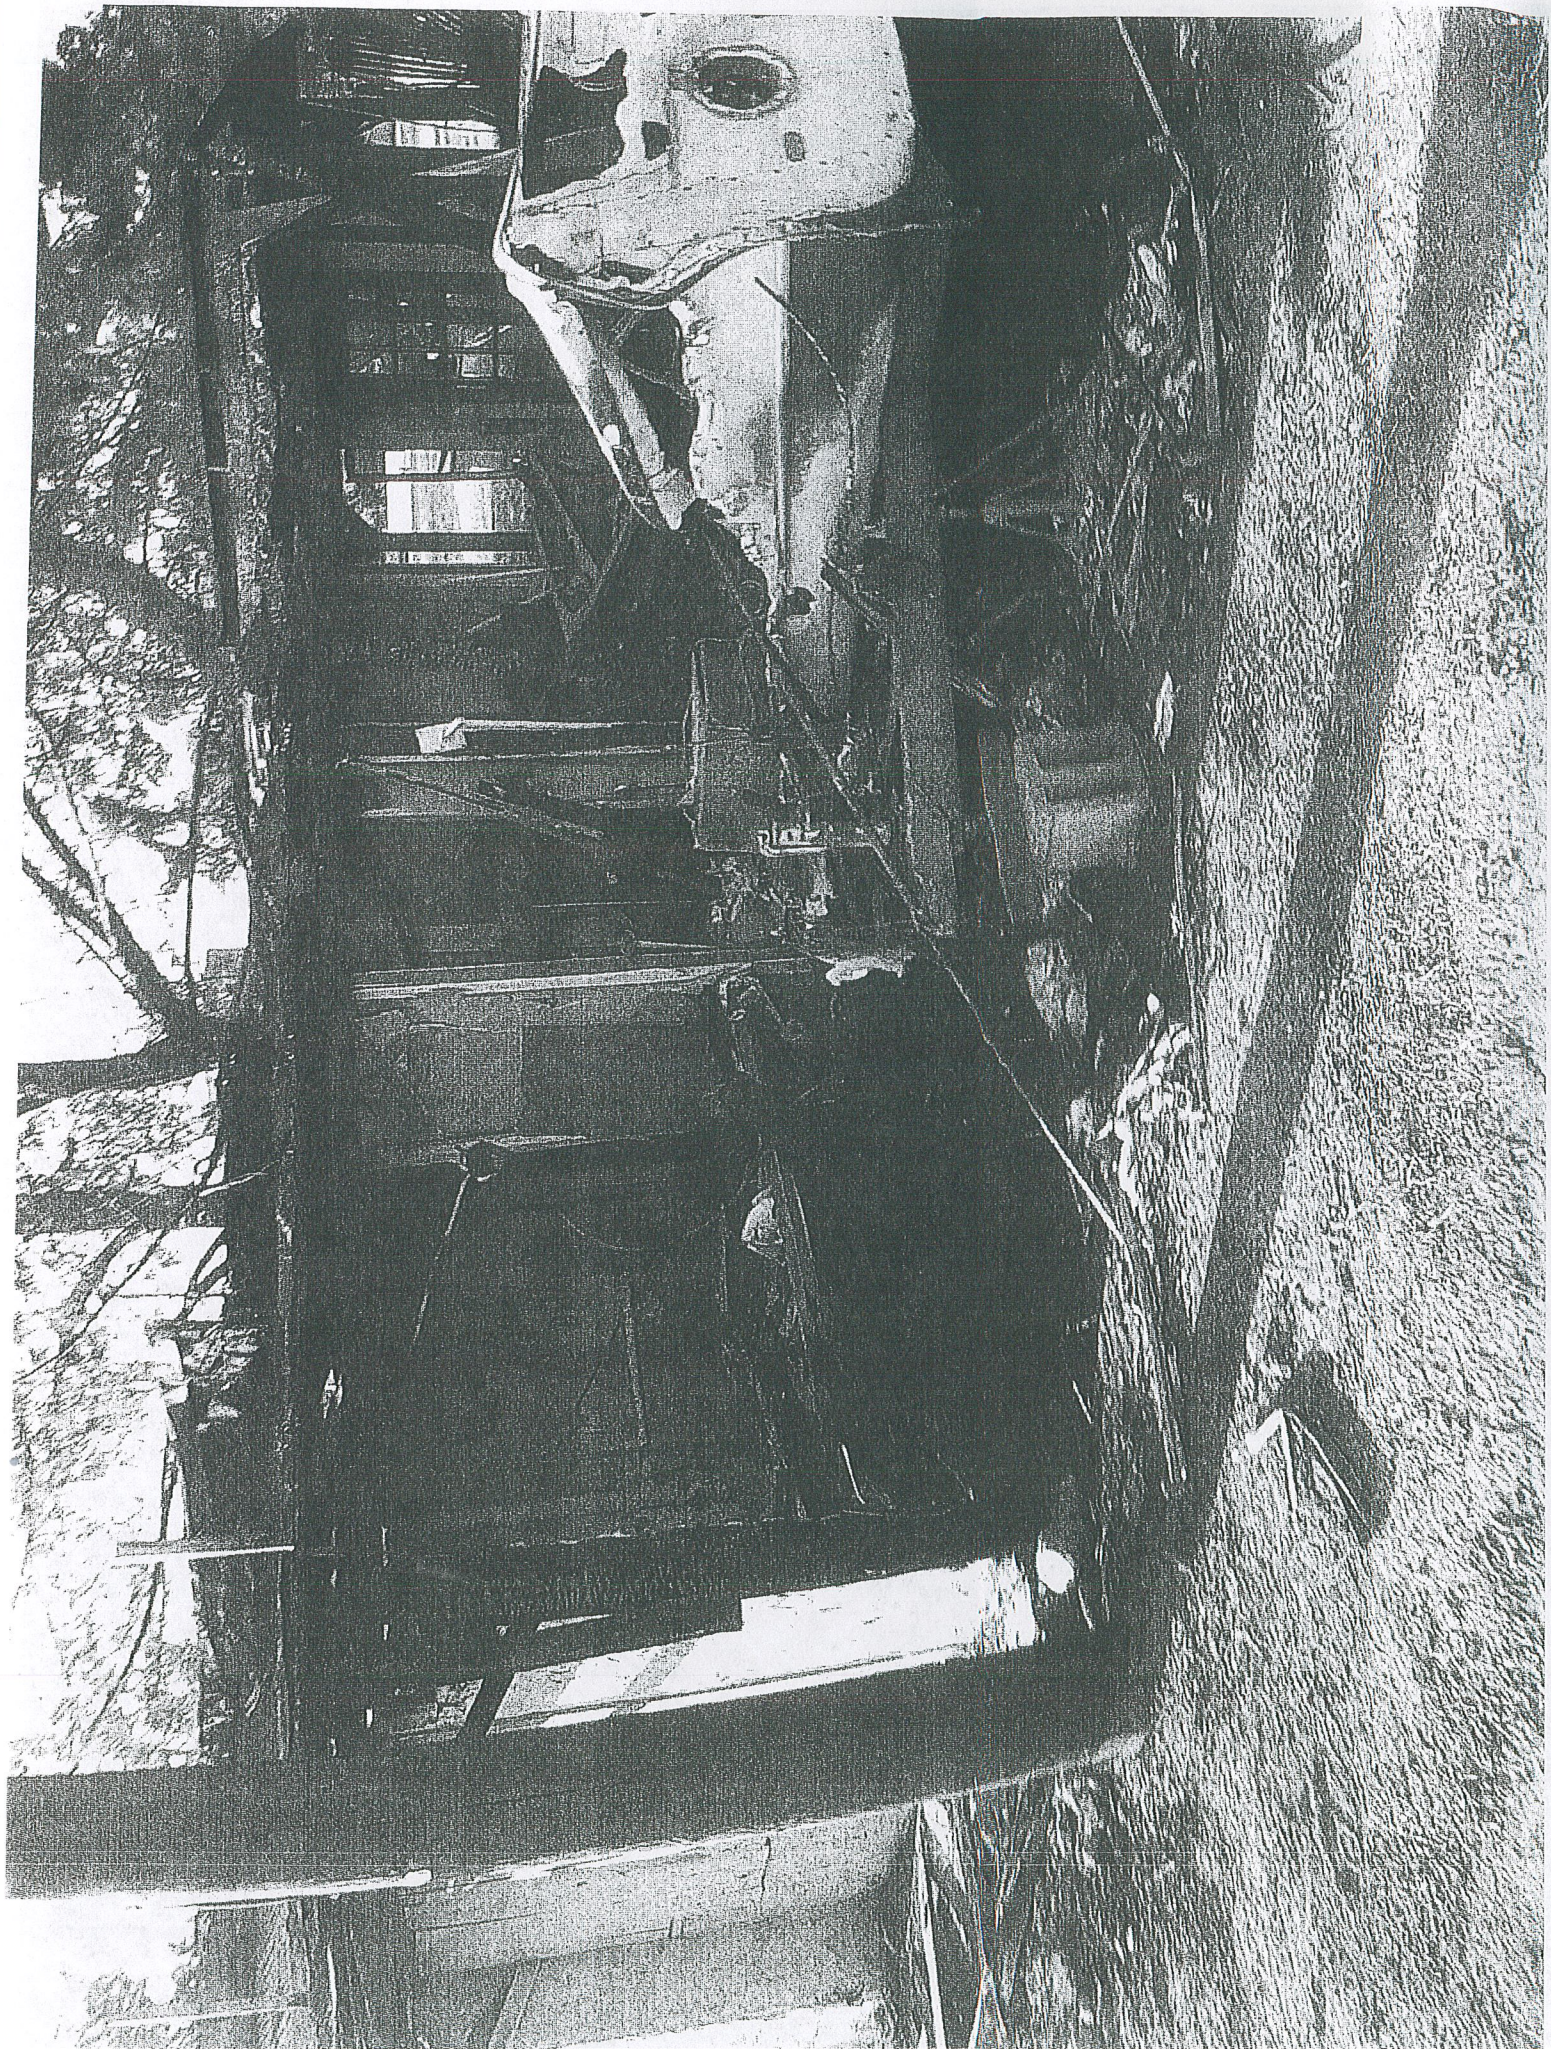
1. The west end of the building has significant fire damage to the supporting walls and roof structure.
2. There is visible structural damage to the roof, and structural support walls and awning support posts.
3. The roof coverings have failed and/or are missing allowing water intrusion into the structure causing damage to the structure.
4. The awning roof on the south side of the structure is failing and collapsing.
5. There are electrical wires and devices installed on the exterior of the property contrary to the requirements of the National Electrical Code and pose a hazard to anyone entering the property.
6. Electrical Service Equipment panels on the north side of the structure are open with the meters still installed.

1. Apartment # 4 western end of the building adjacent to the fire damage:
  - a. Water damage from roof failure.
  - b. Ceiling failing and collapsing into the rooms.
  - c. Water damage visible at several areas of the north wall. Extent of damage to framing unknown without demolition.

- d. Ceiling, walls, and contents all show some degree of damage from excessive moisture.
- 2. Apartment #5:
  - a. Water damage to north exterior wall and west interior wall. Mold and other signs of extensive damage.
  - b. Wood floor in this apartment has failing and is extremely uneven. It appears that the original floor was constructed on or very close to the soils below the structure.
  - c. Ceiling shows water intrusion and damage to the ceiling and roof. Other damage to ceiling caused by vandals.
  - d. Colony of bees in north exterior wall.
  - e. Ceiling, walls, and contents all show some degree of damage from excessive moisture.
- 3. Apartment #6
  - a. Signs of water damage from unknown entry. Ceiling, walls, and contents all show some degree of damage from excessive moisture.
  - b. Mold in north east corner of apartment.

In conclusion, the inspection of the property indicates that the residential building has suffered extensive structural damage due to failure of the weather-resisting envelope and fire damage to exterior support walls and roof.

The property has sustained damage to structural components that reduce or eliminate their ability to perform as intended. The overall condition of the property is a hazard to anyone entering the building or approaching some outside sections. It is recommended that the structure be demolished.
